# THE ROYAL THEATER Hogansville, Georgia

## CURRENT CONDITIONS – BUILDING EXTERIOR

## STRUCTURAL CONDITIONS EVALUATION –

## BUILDING CODE COMPLIANCE EVALUATION –

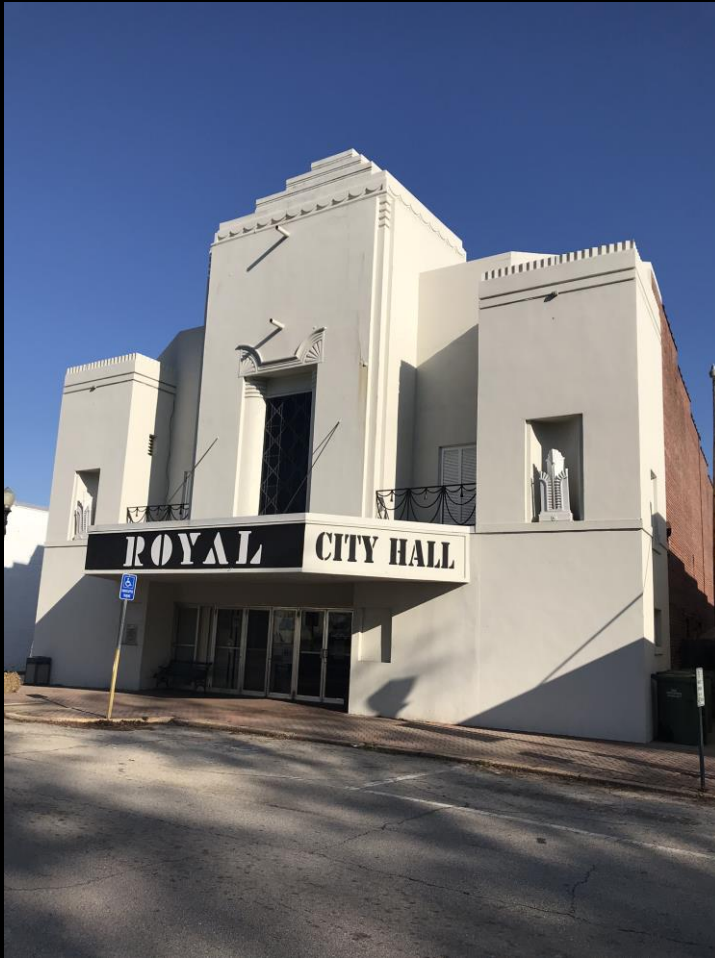
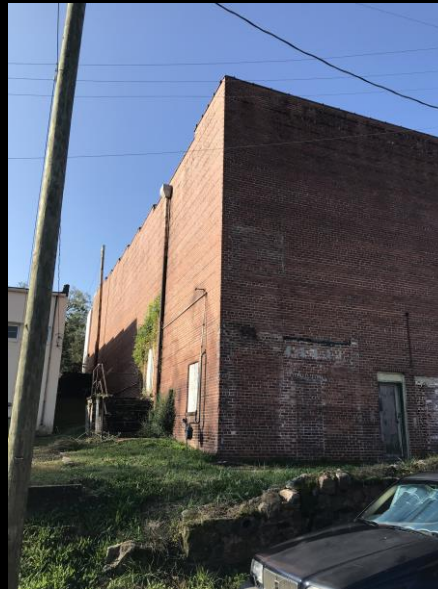
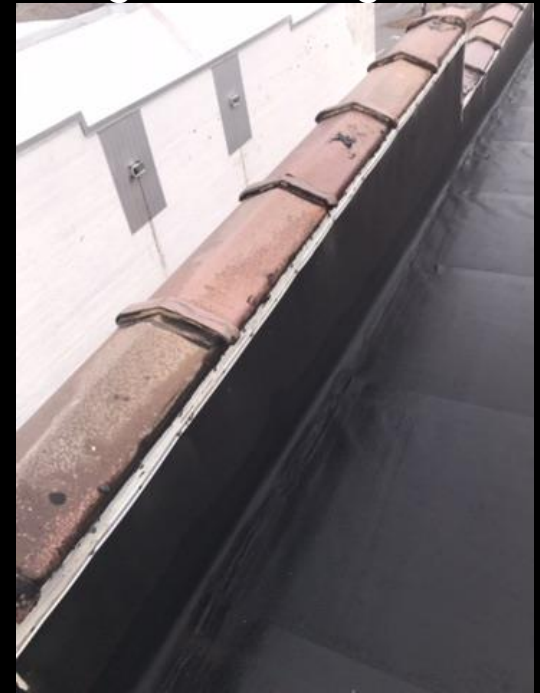
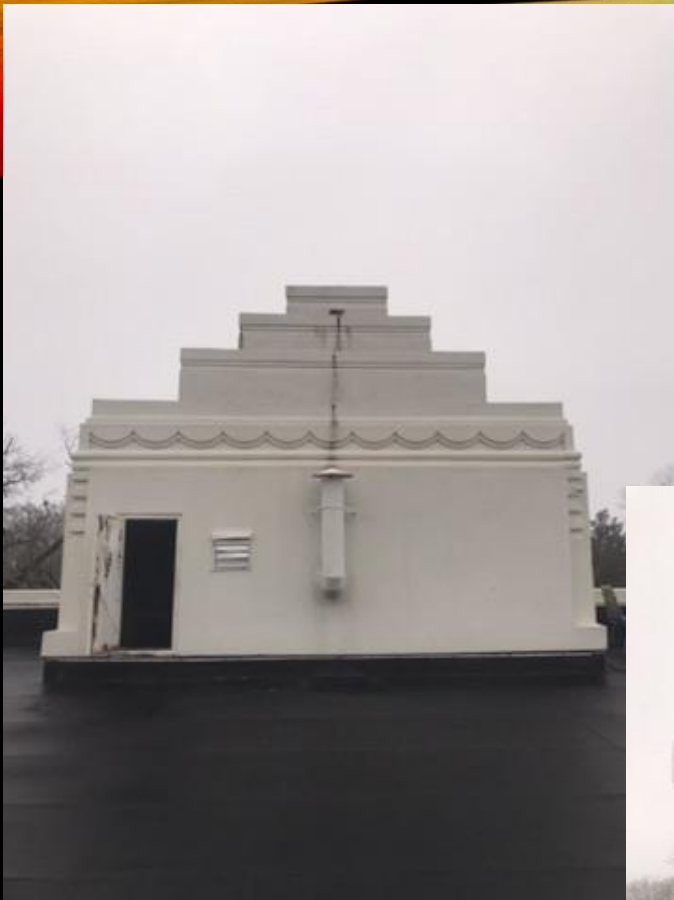
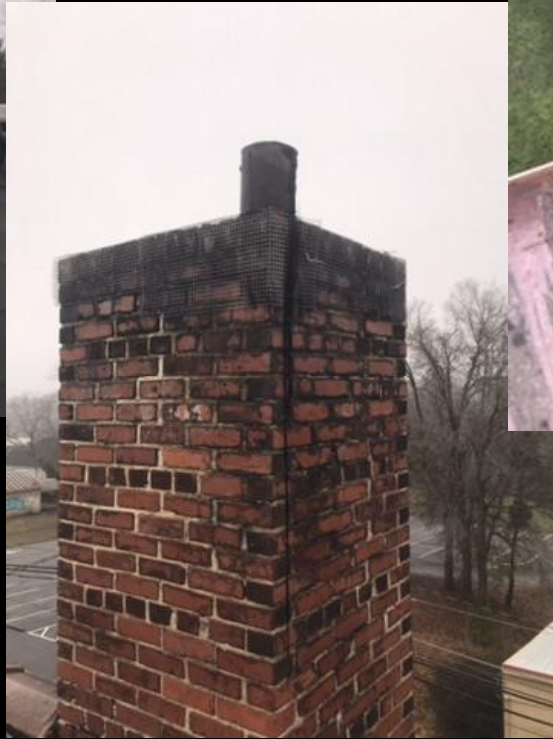
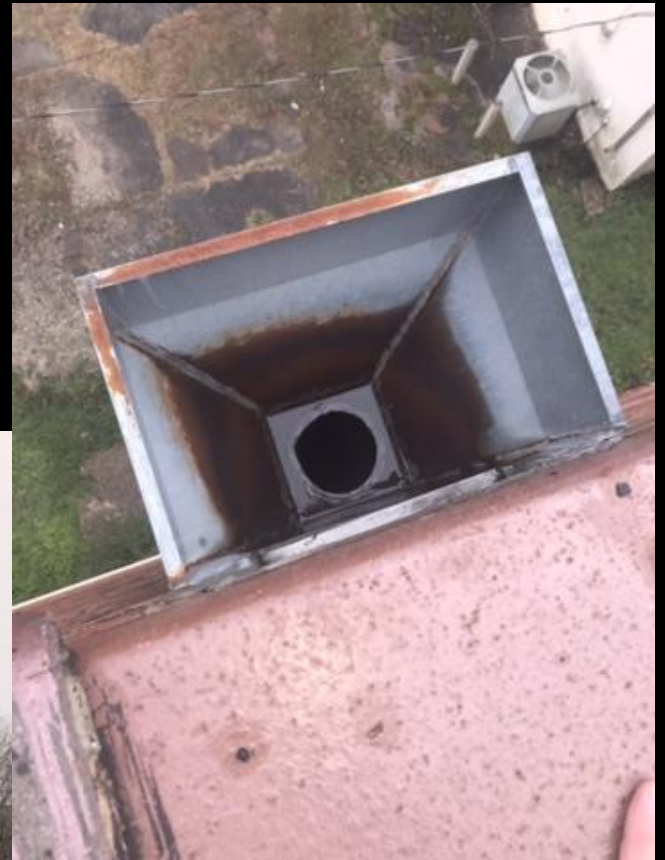
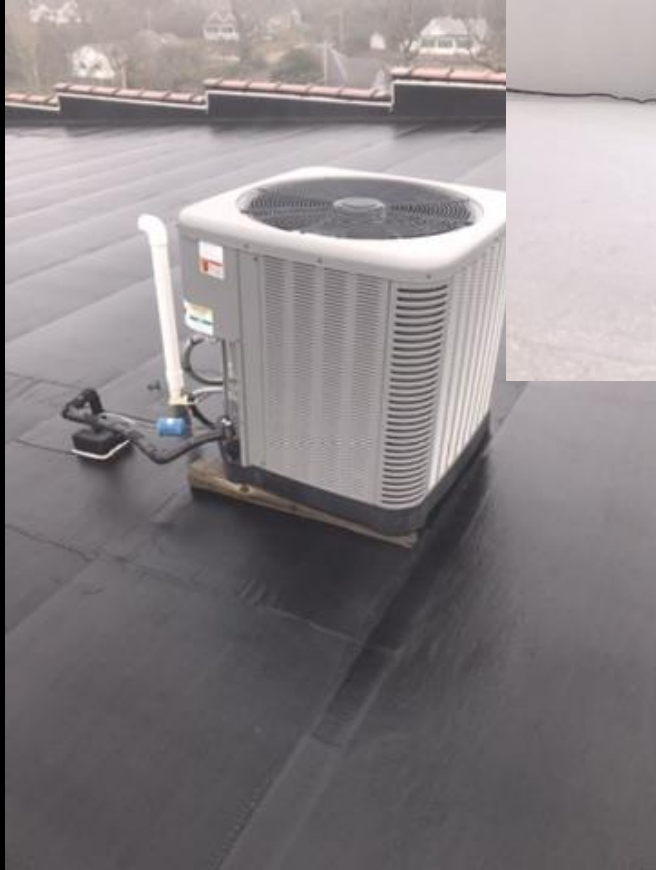
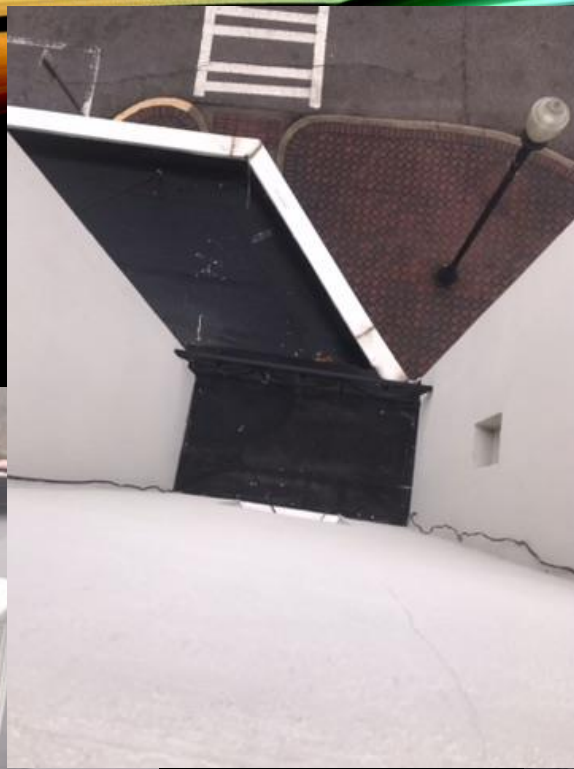
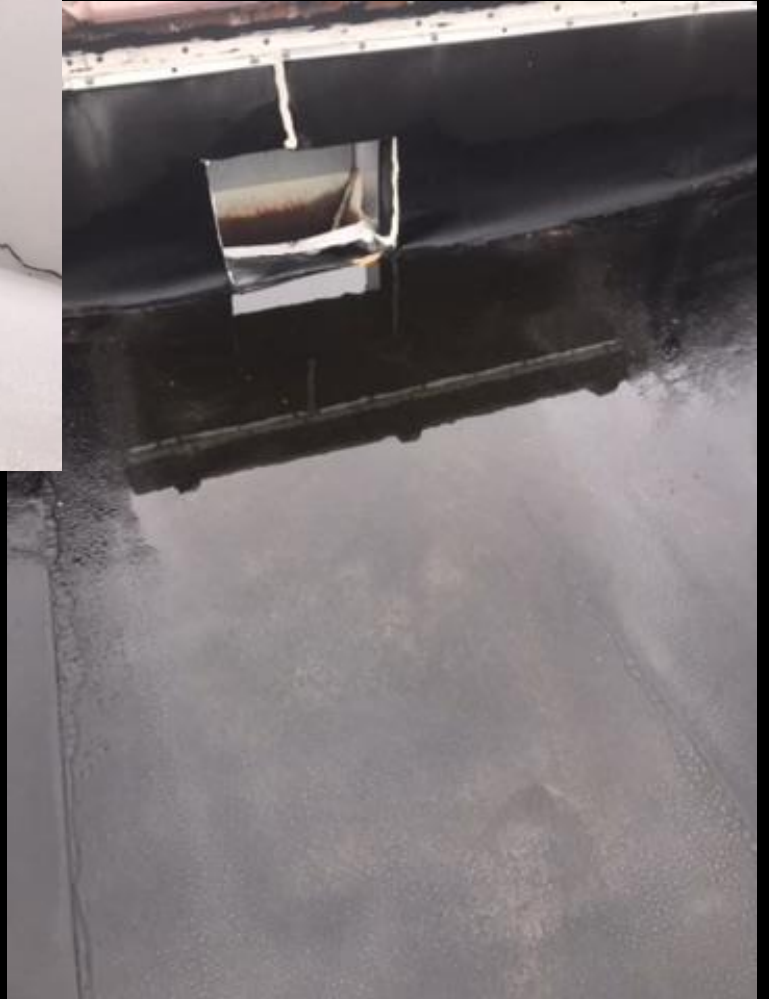
WATER INFILTRATION –  
Stucco has areas of cracking  
Roof coping penetrations  
Roofing material needs replacing  
Brick walls need re-pointing and sealing  
Downspout issue  
Chimney cap

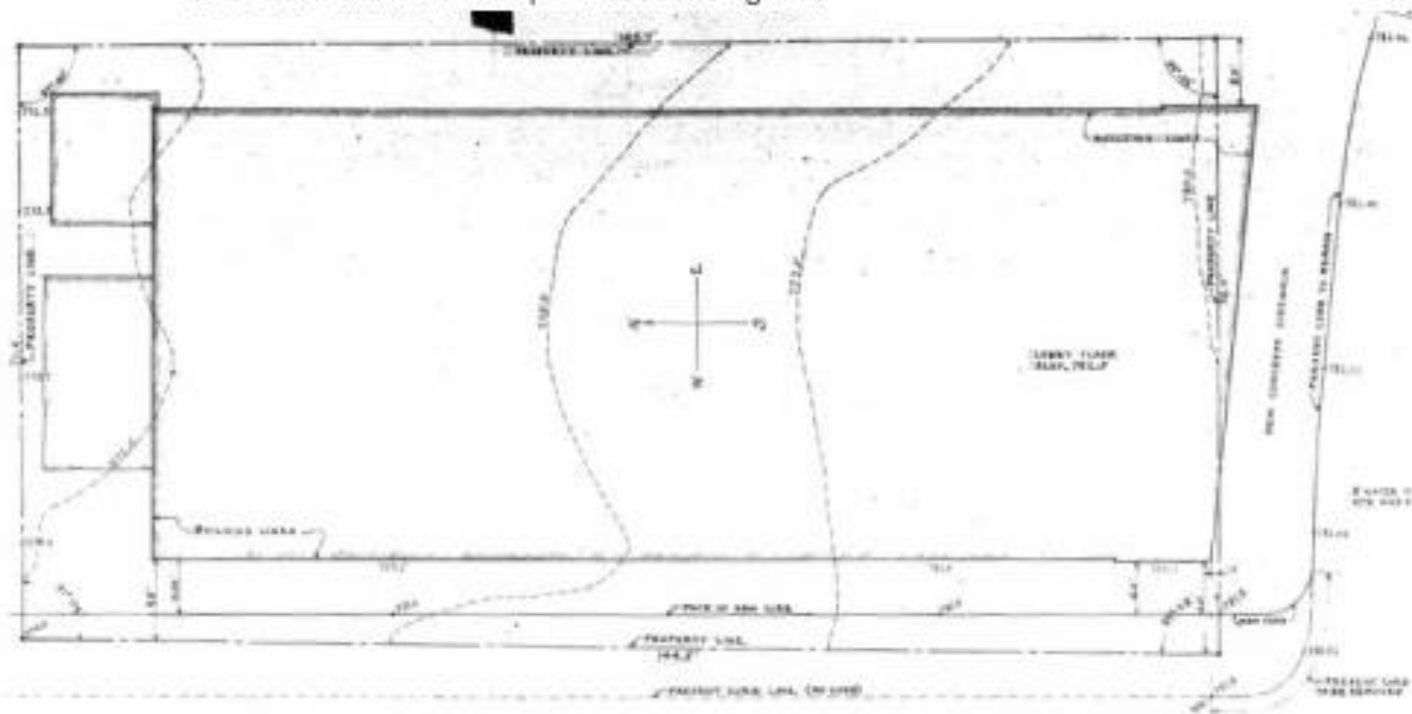
The drawing above shows the building outline on the existing site. From Main street to the rear property line the site sloped 7.5 feet. The Auditorium slopes 4'-4" from the Lobby to the Stage with the Basement area being 8 feet lower for a total elevation change of 12'-4". This means that the basement was excavated below original grade but it also means that the Auditorium and portions of the Lobby slab were built on up to four feet of fill dirt as indicated by the dashed line in the building section below.

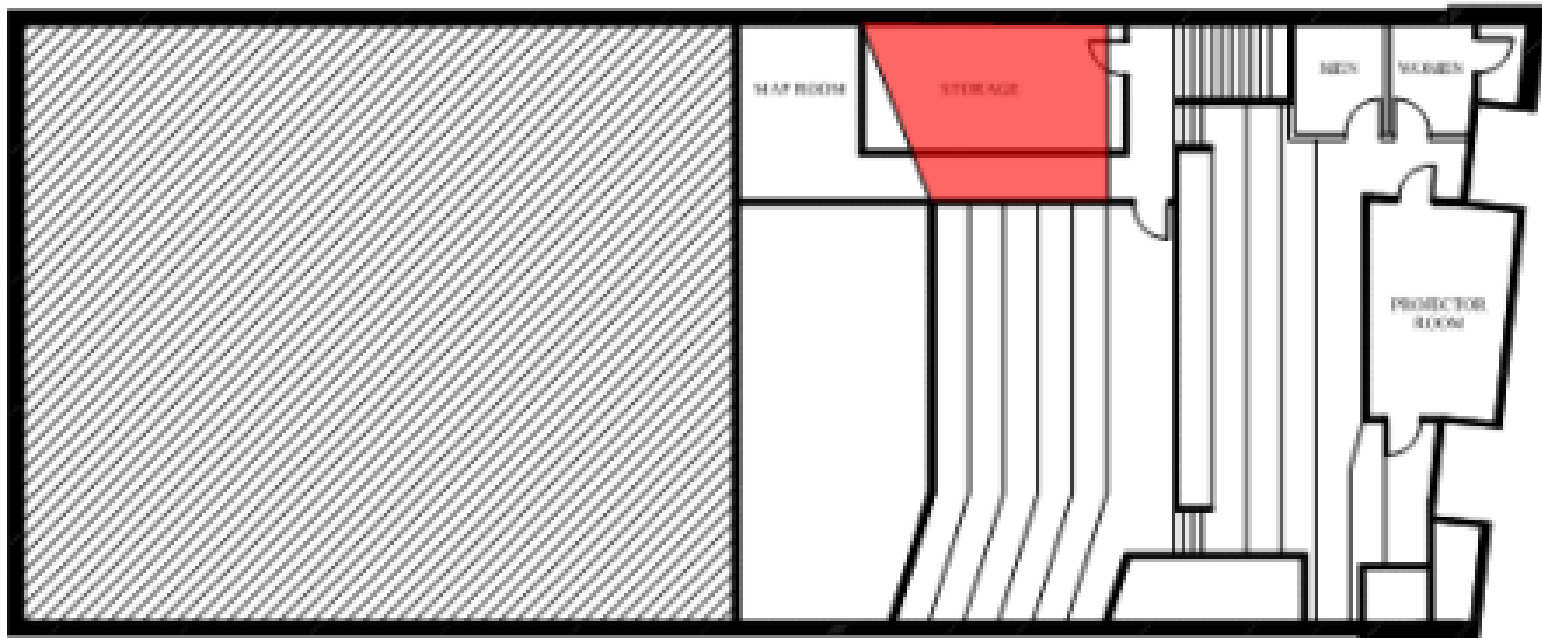
The red shaded area below shows the portion of the 1984 construction which was built on top of the Balcony.

Other than the issues outlined above, the only other concern regarding the 1984 modifications would be the adequacy of the floor framing especially considering the load requirements for the Council Chambers. No other issues provided no other structural concerns.

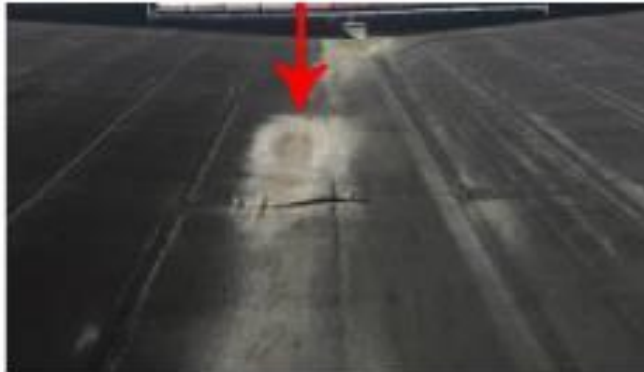
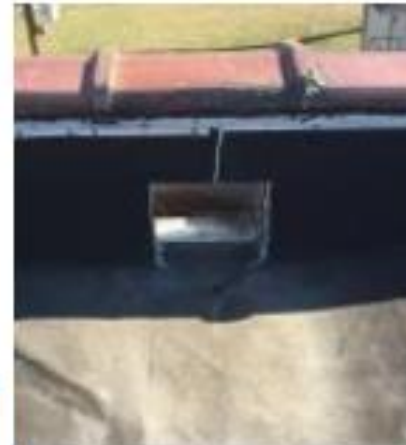
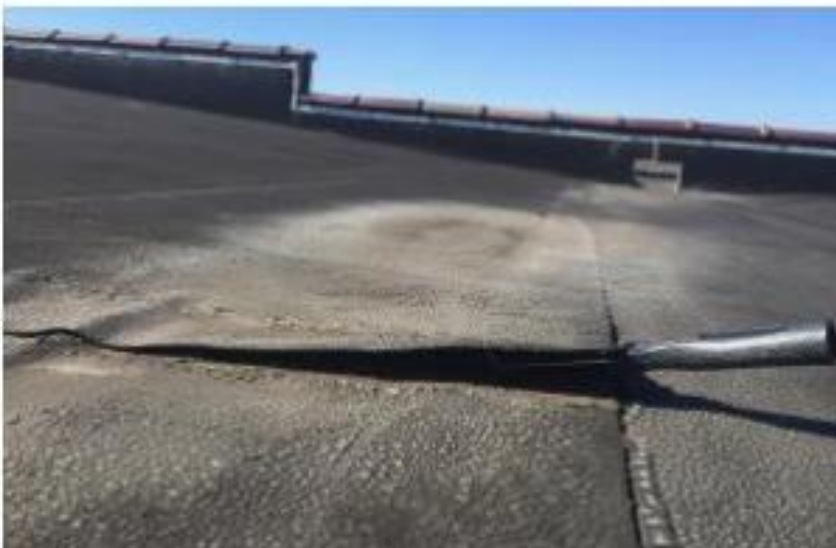
Photos at left shows the basically flat valley and stains indicate that the water ponds in the valley in lieu of being adequately directed to the scuppers.

The scuppers are the second issue. They appear to be too high for the roof which caused water to pond at the scuppers as well.

Additionally, the scuppers are improperly flashed which means that they are allowing water to migrate down the inside of the brick wall.

The last issue is the roofing material itself. The aged roof has problems with seam penetrations, ripples, and is well beyond its life expectancy.
