# THE ROYAL THEATER Hogansville, Georgia

## CURRENT CONDITIONS – BUILDING EXTERIOR

## STRUCTURAL CONDITIONS EVALUATION –

## BUILDING CODE COMPLIANCE EVALUATION –

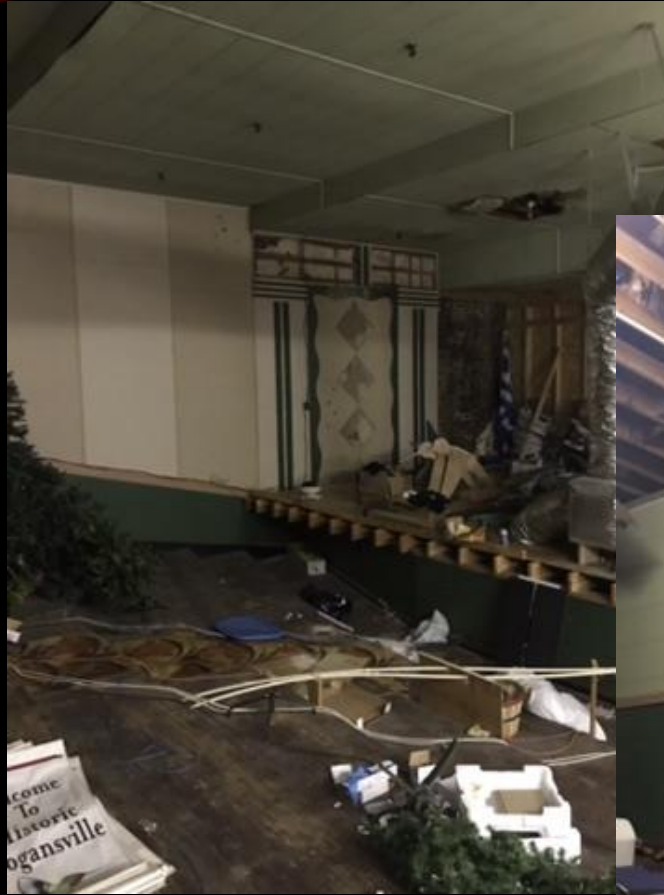
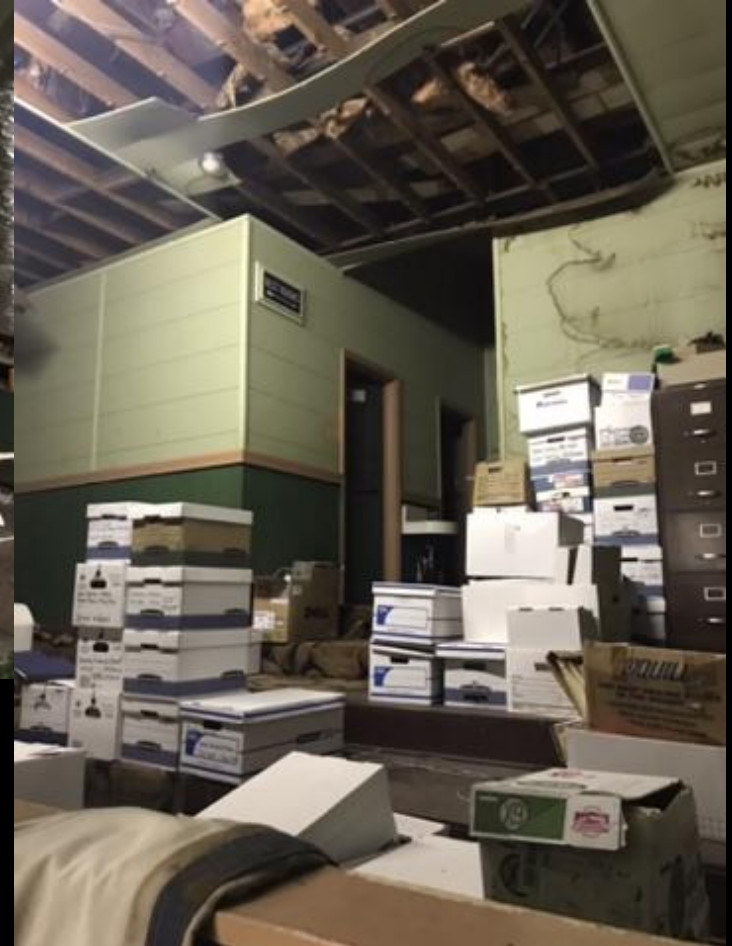
# CURRENT CONDITIONS – BUILDING INTERIOR

- Water damage
- Code Compliance
- Accessibility
- Systems Efficiency
- Floor Plan issues
- Future Expansion

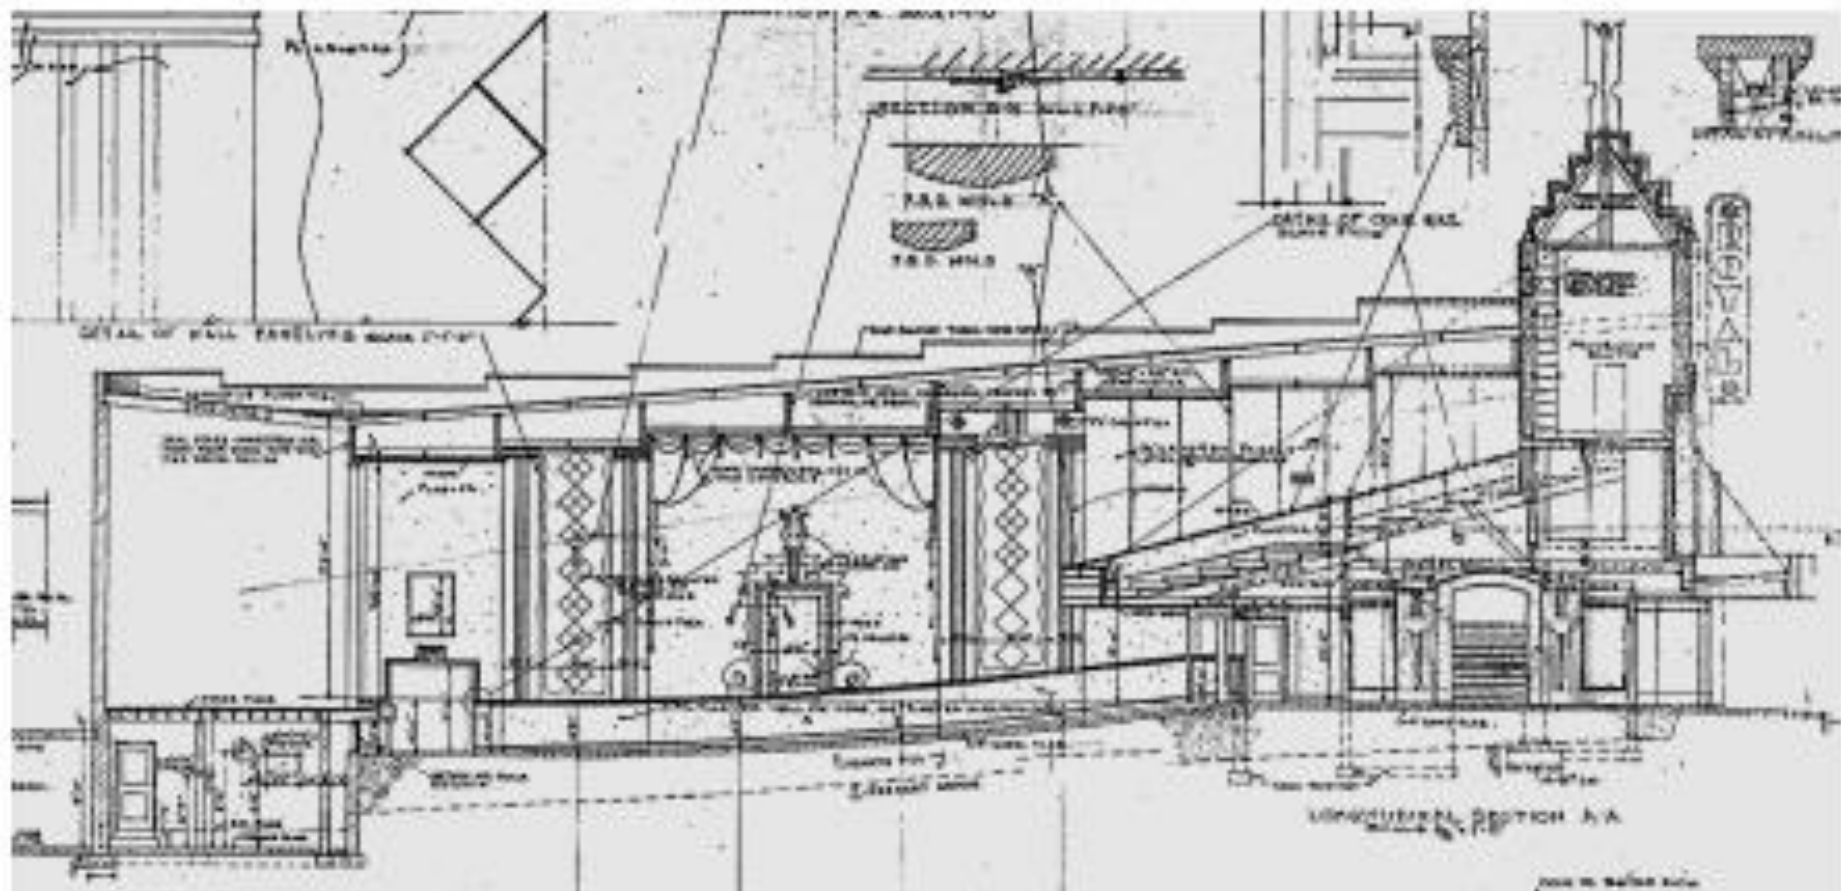
The original drawings contain a building section that provides ample information regarding the structure of the building. Along with the support details of the marquee and the tower construction, these documents provide invaluable insight and an ability to review the structural issues.

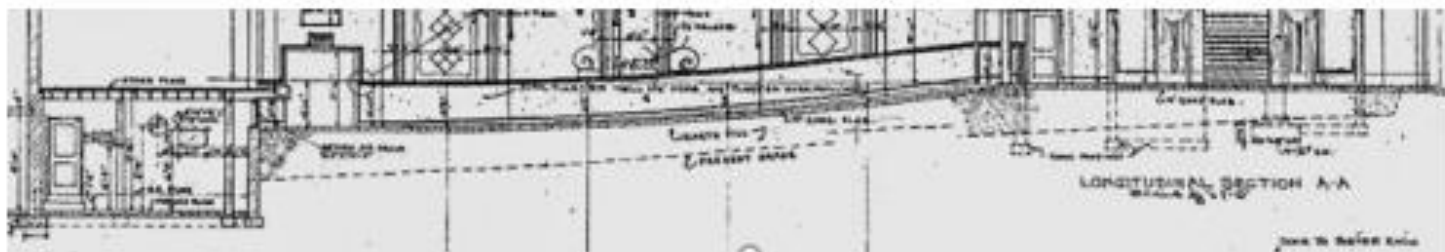
The drawing above shows the building outline on the existing site. From Main street to the rear property line the site sloped 7.5 feet. The Auditorium slopes 4'-4" from the Lobby to the Stage with the Basement area being 8 feet lower for a total elevation change of 12'-4". This means that the basement was excavated below original grade but it also means that the Auditorium and portions of the Lobby slab were built on up to four feet of fill dirt as indicated by the dashed line in the building section below.

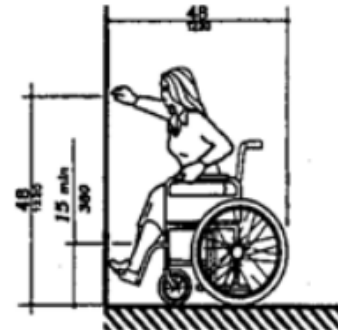
High Forward Reach Limits

1. Lack of an Accessible Route to all portions of the building. If the Auditorium were used, the route from the front door to the Auditorium would not comply.
2. Ensure toilet rooms comply.
3. Adequate space allowances and reach ranges for wheelchairs are not met. Hallways do not allow adequate maneuvering or passing space for wheelchairs and all openings are required to be 32" clear.
